MARINE INVESTIGATION REPORT
M00L0034

MAIN ENGINE FAILURE

GENERAL CARGO CARRIER *MILLENIUM YAMA*
ST. LAWRENCE RIVER
11 APRIL 2000

Report Number M00L0034

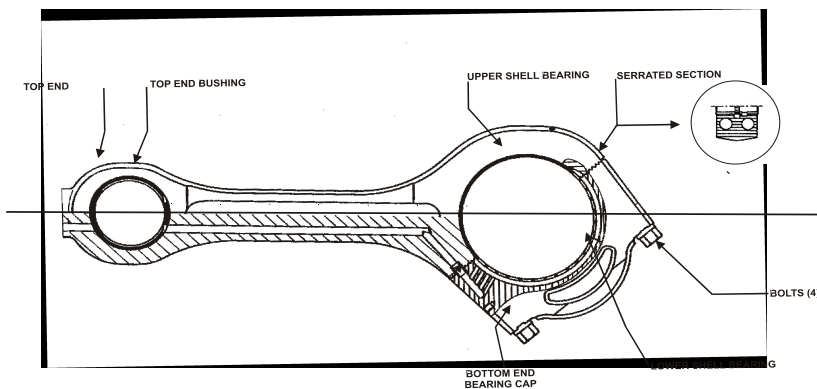
Figure 2. Angled split connecting rod.

The manufacturer recommends that con-rods be inspected as follows, after 24,000 running hours:⁶

- Measure the inner diameter of the bush.
- Conduct a Dye Penetration Test of the con-rod cap serrated faces of the oblique bottom end joint. Any crack shall be submitted to an examination by the manufacturer, who will decide whether the con-rod cap is to be rejected.
- Perform a Magnetic Particle Crack-Detection Test on the con-rod bottom end screws or bolts. Failing that, carry out a Dye Penetration Test.
- Perform a dimensional inspection of the connecting rod bottom end bore.
